COHANSEY RIVER  
CUMBERLAND COUNTY  
NEW JERSEY

# SUNSET LAKE DAM

## NJ 00063

### PHASE 1 INSPECTION REPORT NATIONAL DAM SAFETY PROGRAM

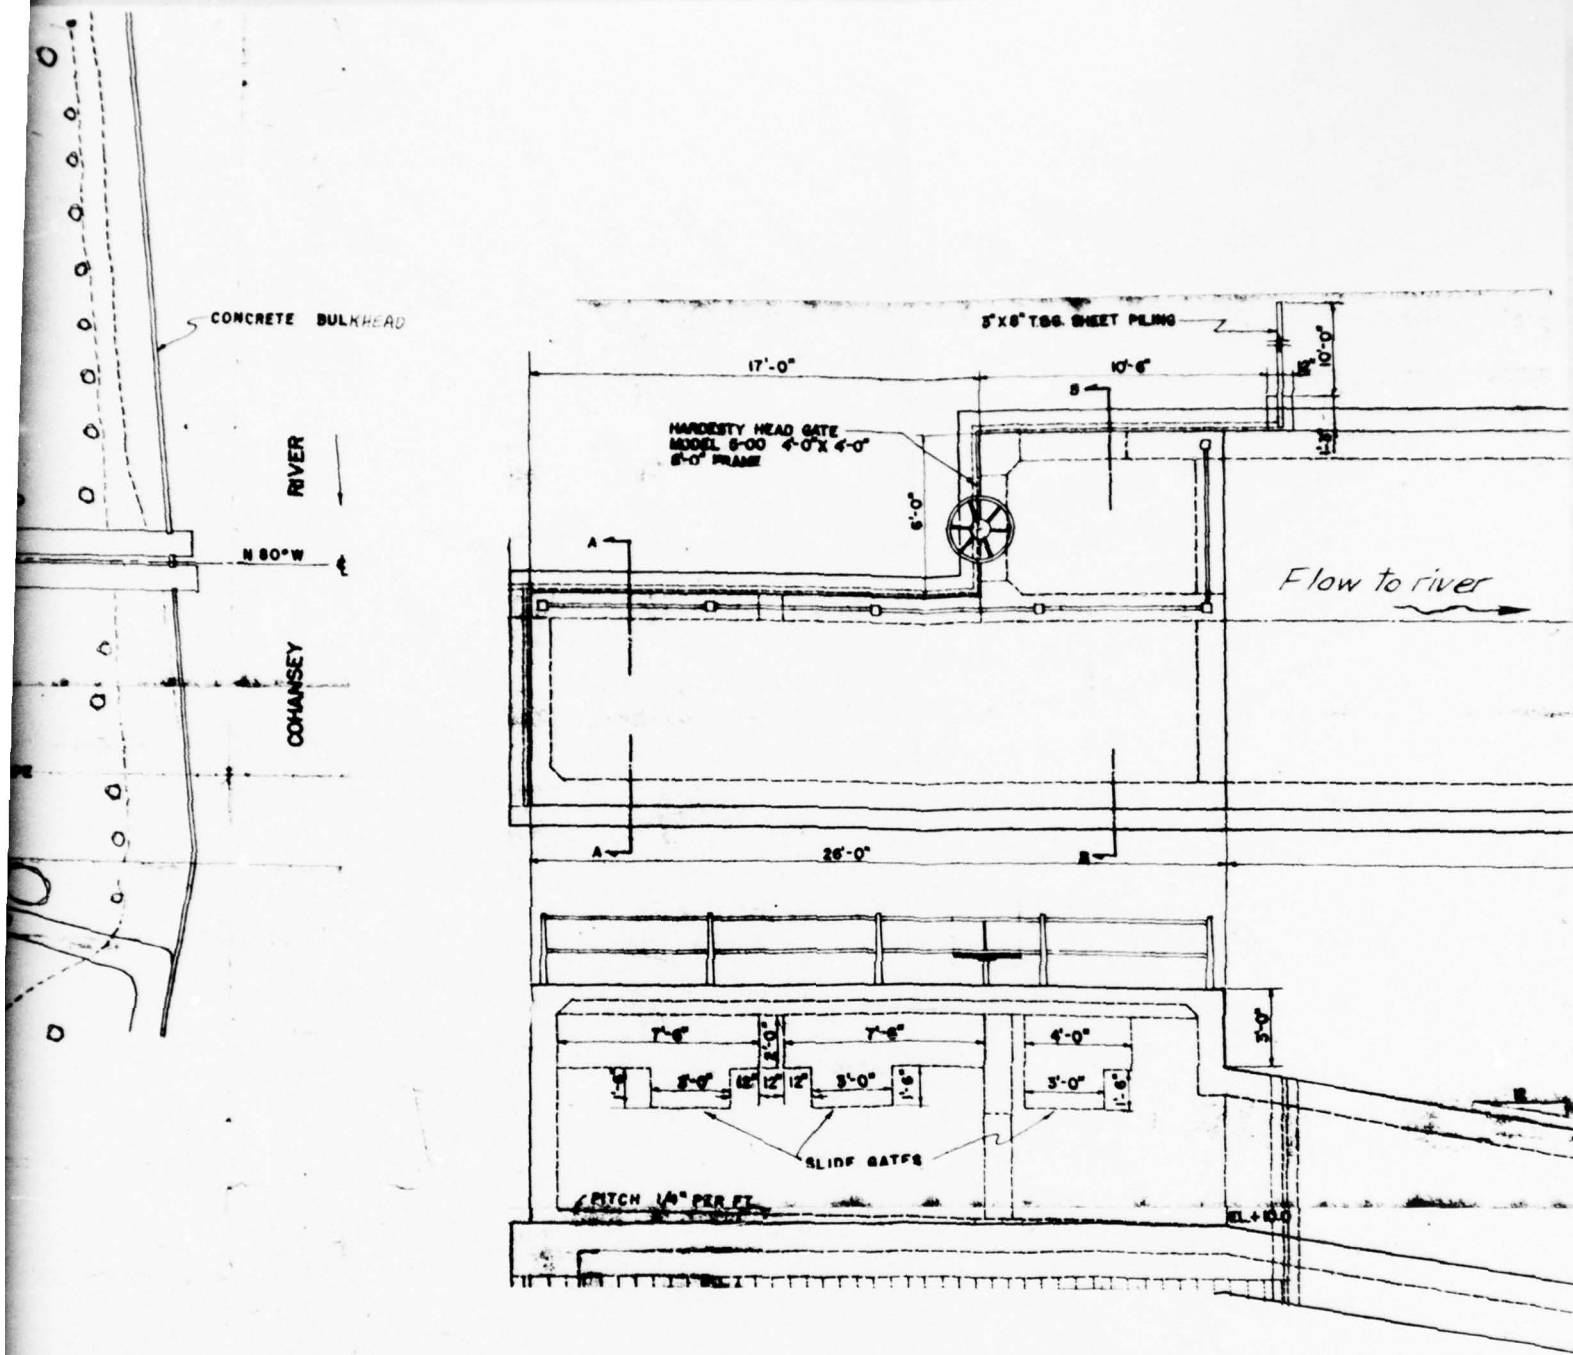
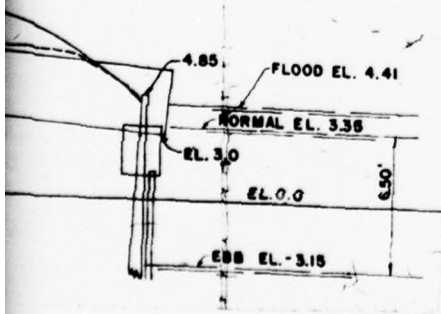
FIGURE 3

The notched-weir drop inlet at the south end of the raceway (see Figure 3) replaced two

earlier 4' x 4' gates which originally discharged the raceway flow into a timber flume that apparently continued southward to the historic nailworks. The present structure has two 7'-6" and one 4'-0" wide notched weir openings and discharges into a concrete chamber which dumps directly into the Cohansey River through two 36" x 58" elliptical CMP. Although the intake structure is old, it is in an adequately structural condition with no major cracking although the concrete surfaces are badly deteriorated.

INTAKE STRUCTURE  
AT  
SOUTH END OF RACEWAY

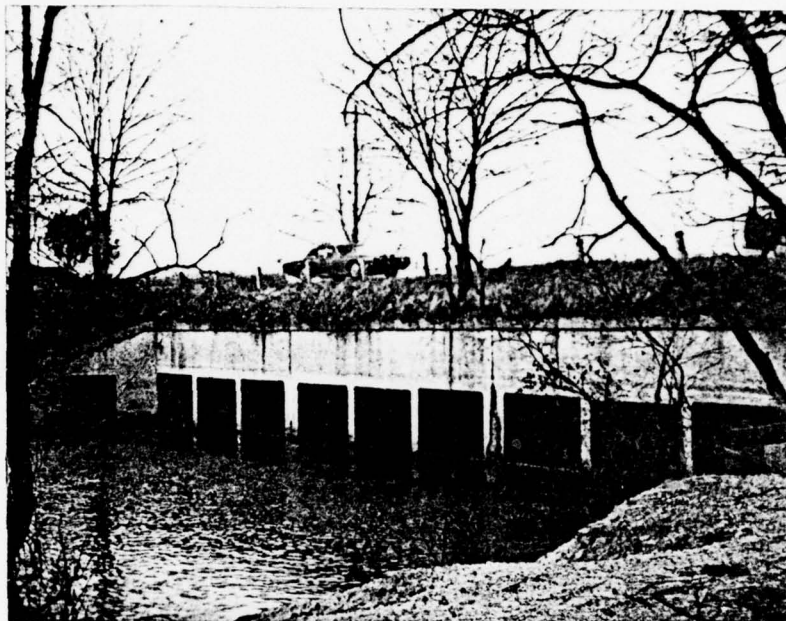
Outlets from siphon spillways

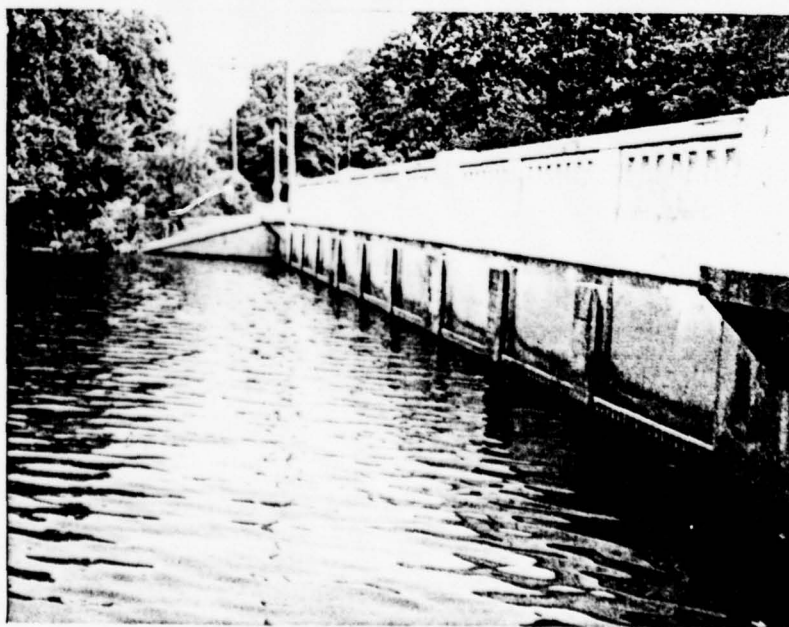
Intakes for siphon spillways

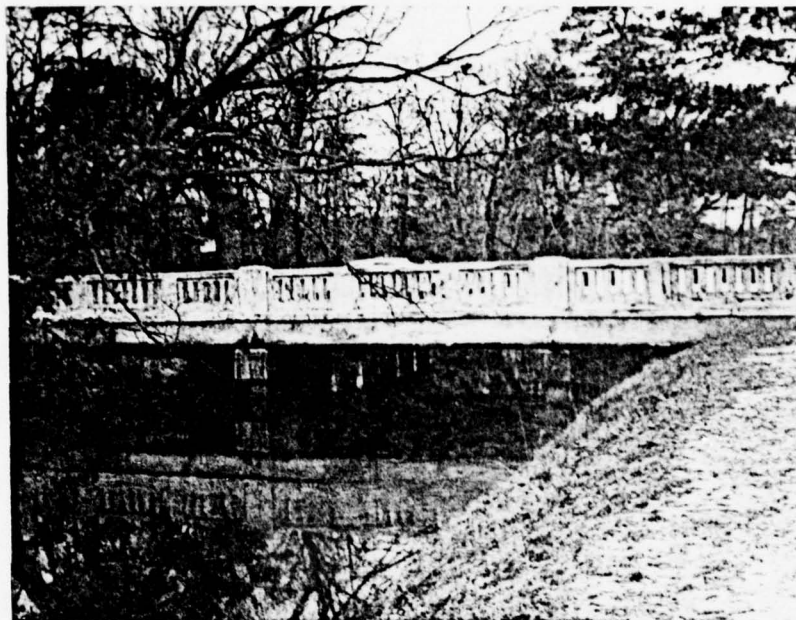
Bridge over raceway near right abutment

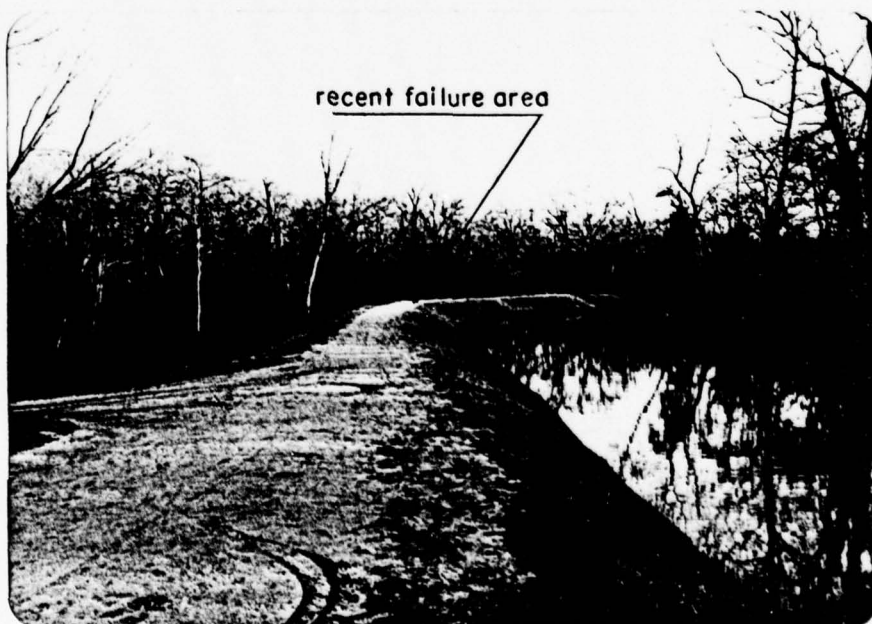
Raceway immediately downstream of bridge

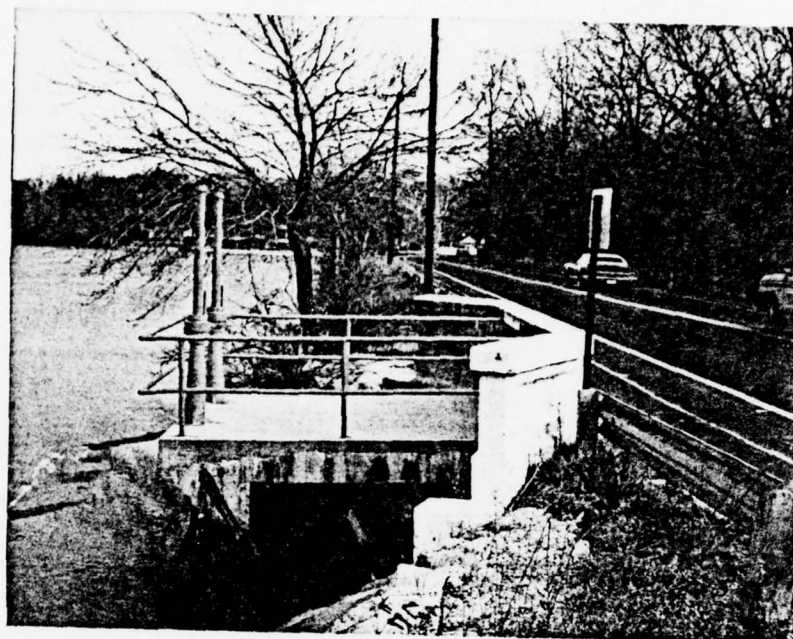
The 9 x 5 foot auxiliary spillway culvert and the 42" sluice gates are in satisfactory condition but there has been some minor differential shifting

Auxiliary spillway and gates

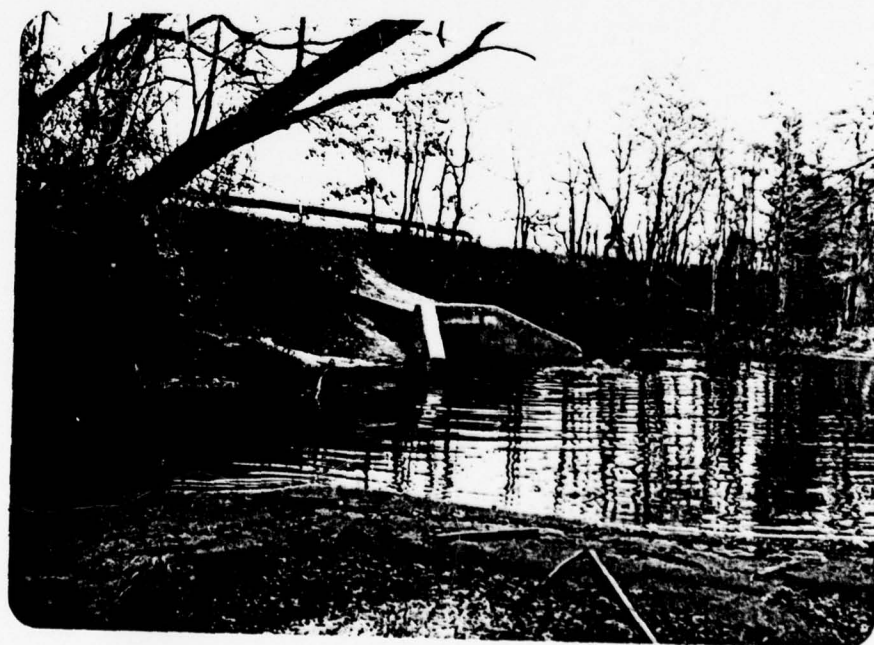
Outlet from auxiliary spillway

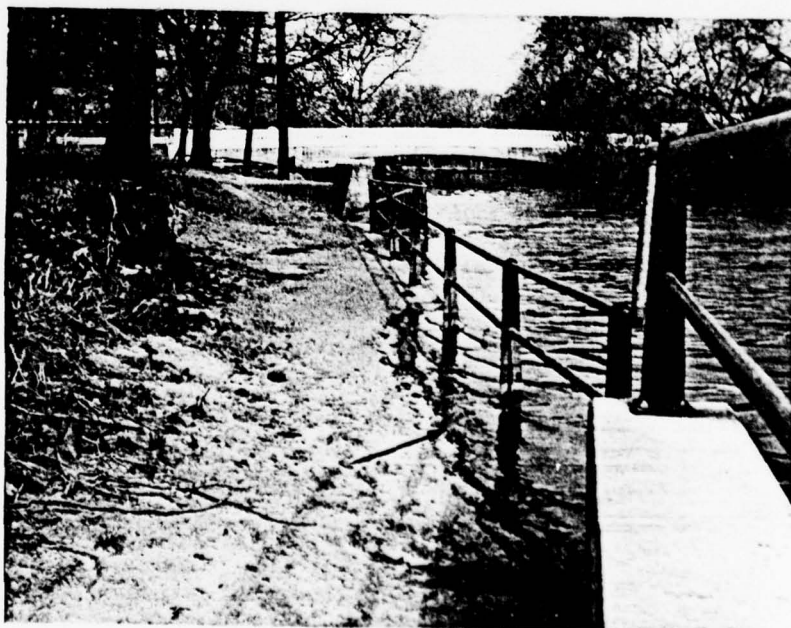
Cohansey River at raceway outlet

(Note: overtopping of concrete wall)

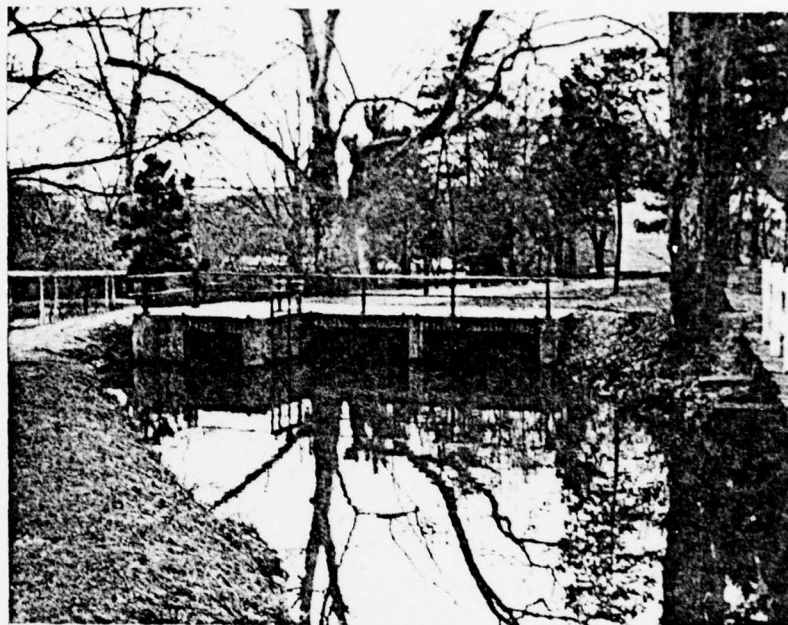
Box culvert at end of raceway

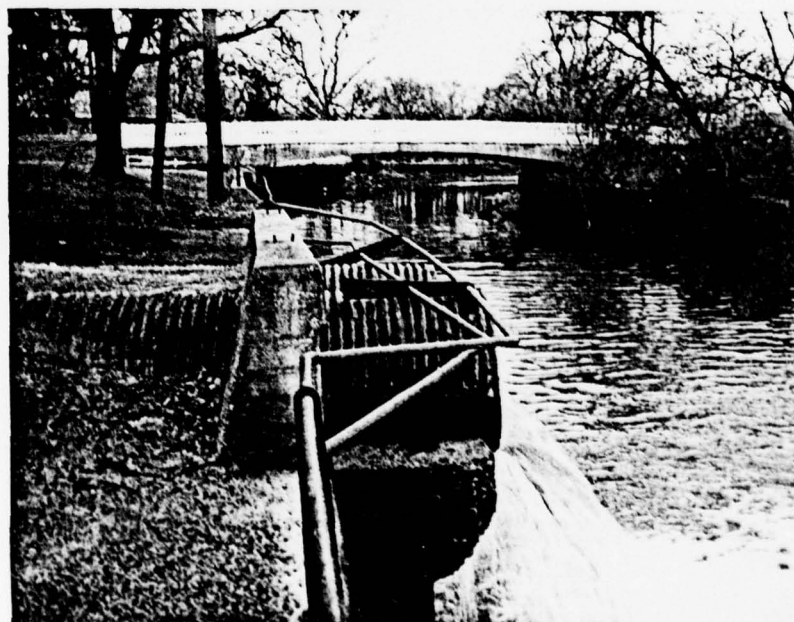
Discharge from raceway into Cohansey River
